## **SALMON PROTECTION AND WATERSHED NETWORK**

### **Lagunitas Creek Floodplain Restoration and Riparian Enhancement Project: Post-Construction Monitoring Report**

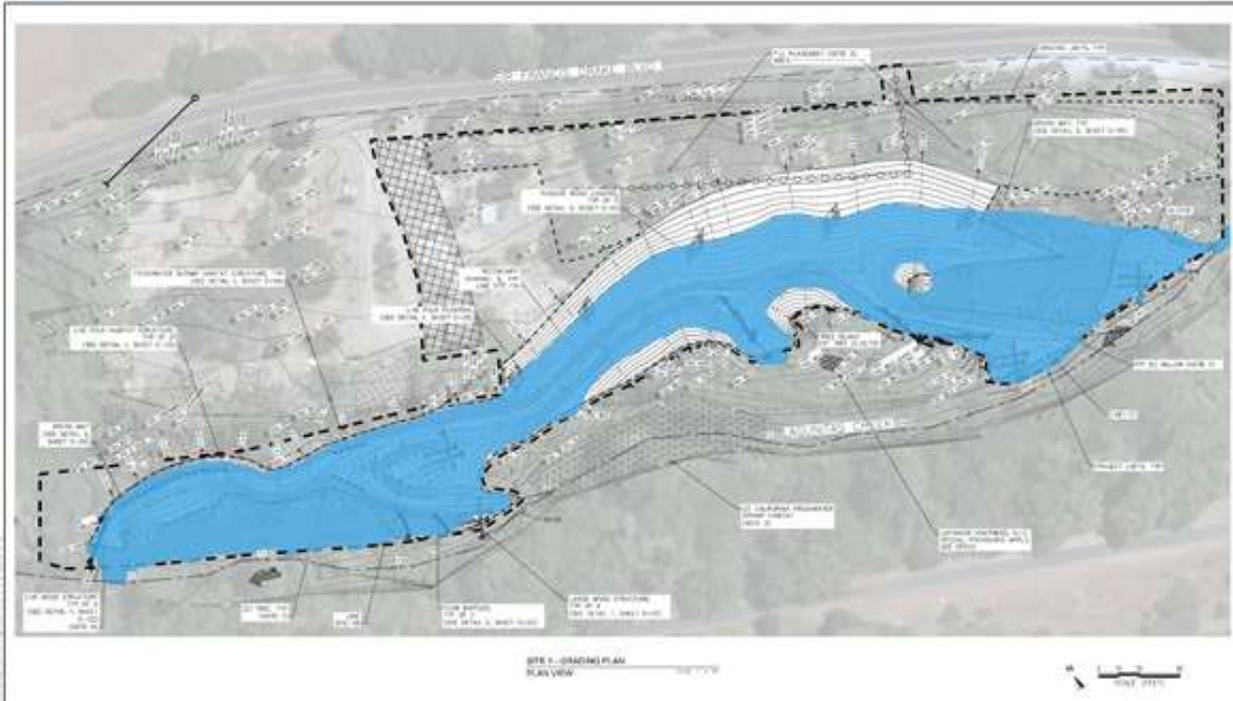
**Figure 1.** This shows the spatial extent of water inundation on February 27, 2019 at approximately 12:30pm. The discharge measured at the Devils Gulch stream gauge 2 miles upstream at this time was approximately 2,030 cfs.

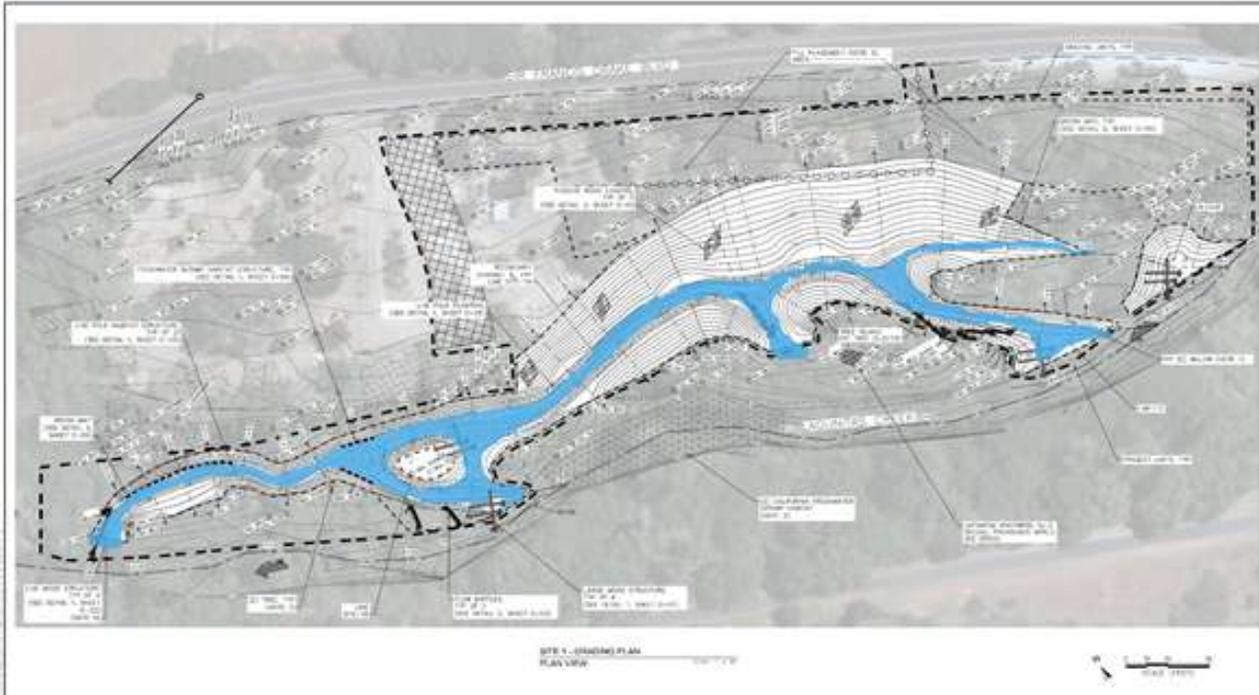
**Figure 2.** This shows the spatial extent of water inundation on March 01, 2019 at approximately 10:40am. The discharge measured at the Devils Gulch stream gauge 2 miles upstream at this time was approximately 304 cfs.

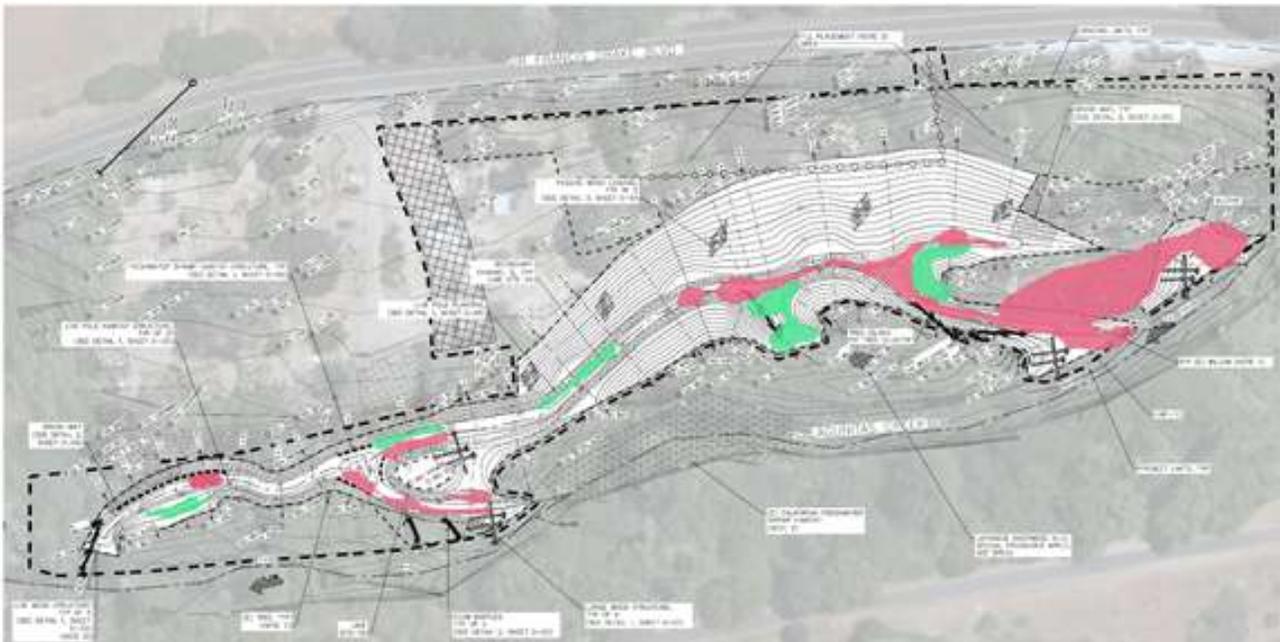
**Figure 5.** Coarse sediment (>10mm in red) and fine sediment (<2mm in green) deposited in select areas during the winter of 2018-2019, primarily as a result of high flows approaching 4,000 cfs.

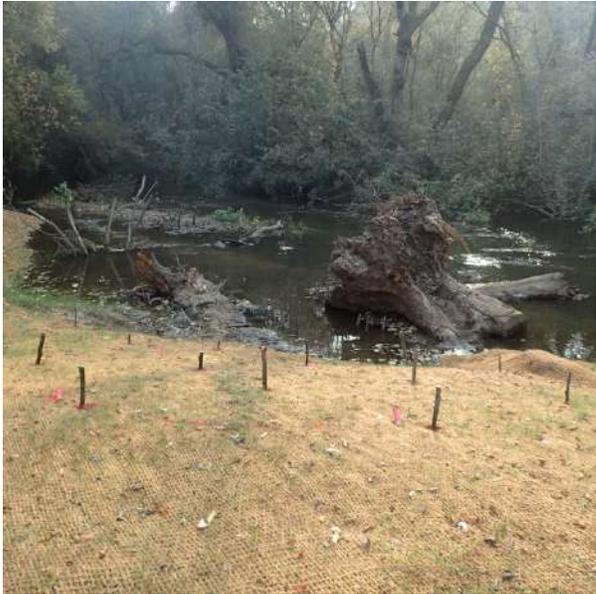
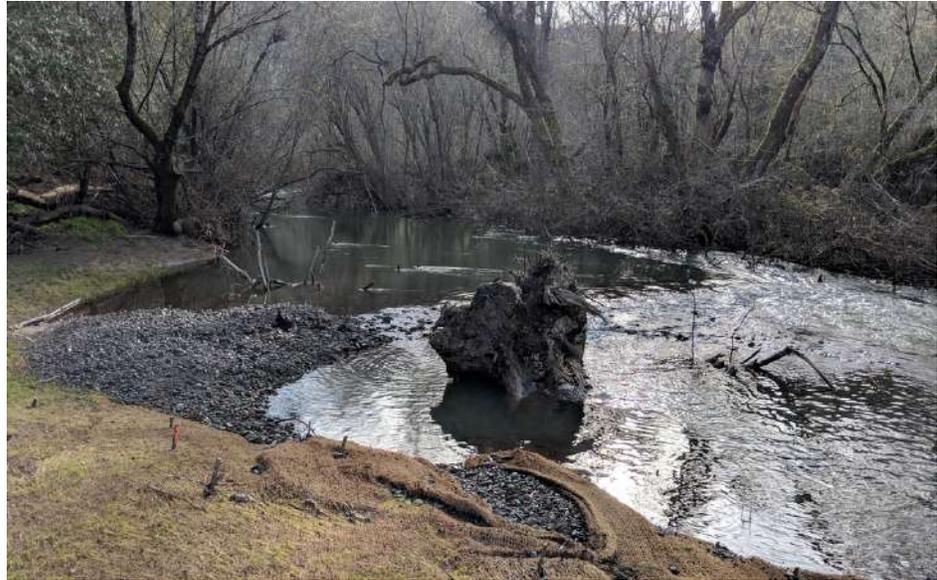
Note the accumulation of gravel at the riffle crest. Water surface raised approximately 3 feet.

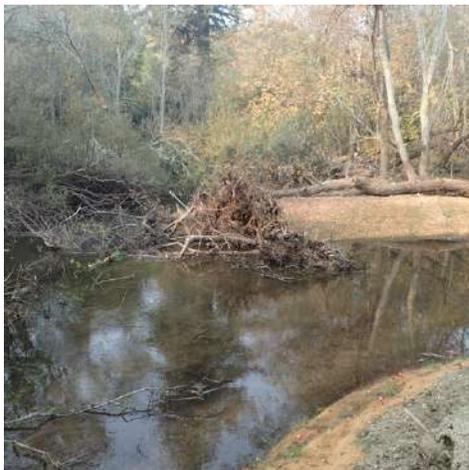
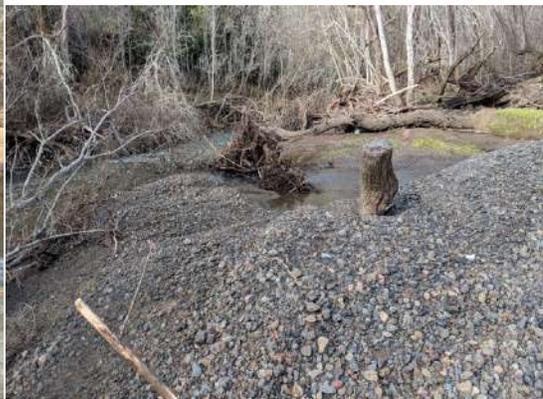
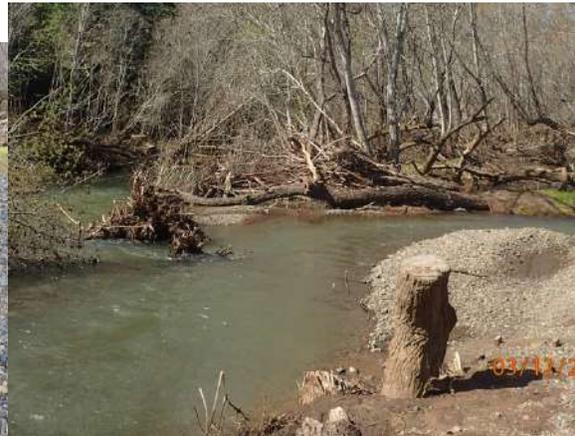
Note the large accumulation of gravel (middle photo) at the inlet of the seasonal channel during the February 2019 storms. Following the February storm events, the gravel that accumulated at this inlet was transported further downstream into the seasonal channel.

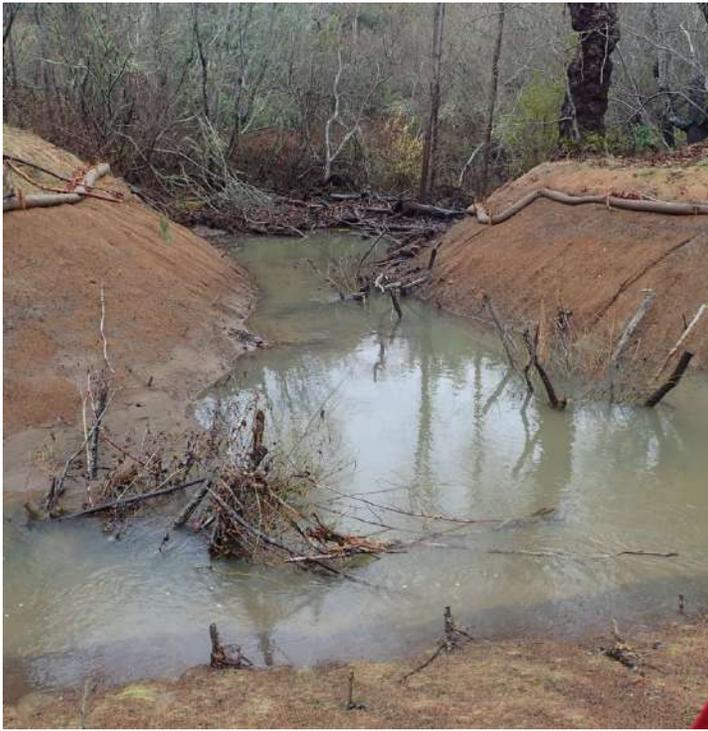
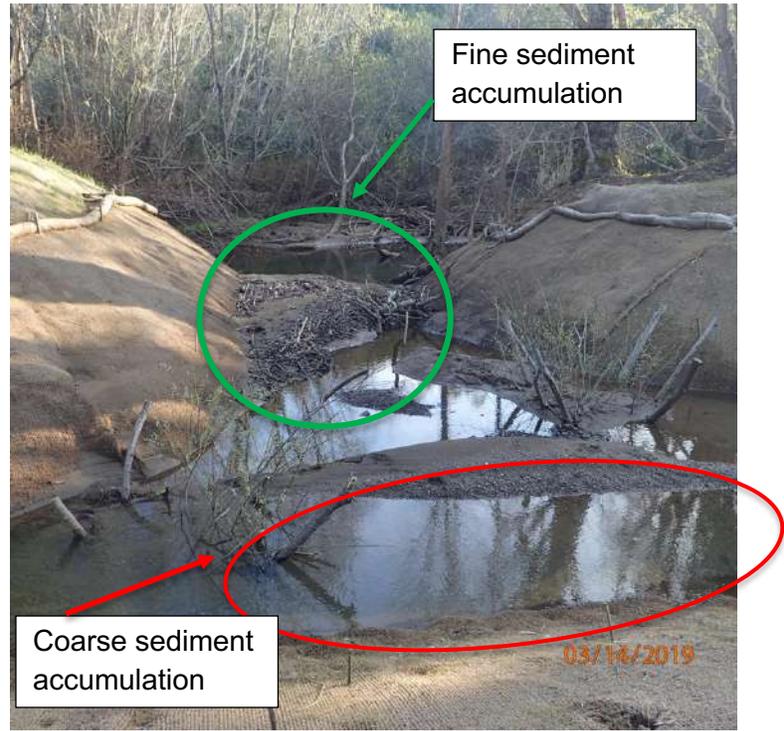
Note the significant accumulation of fine sediment in the center of the lateral channel connection. This material is composed primarily of sand and wood. In the lower portion of the photo on the right is coarse material that accumulated in the channel where sediment transport capacities are higher. This is an example of how sediment is sorting and metering due to undulating topography and small instream wood.

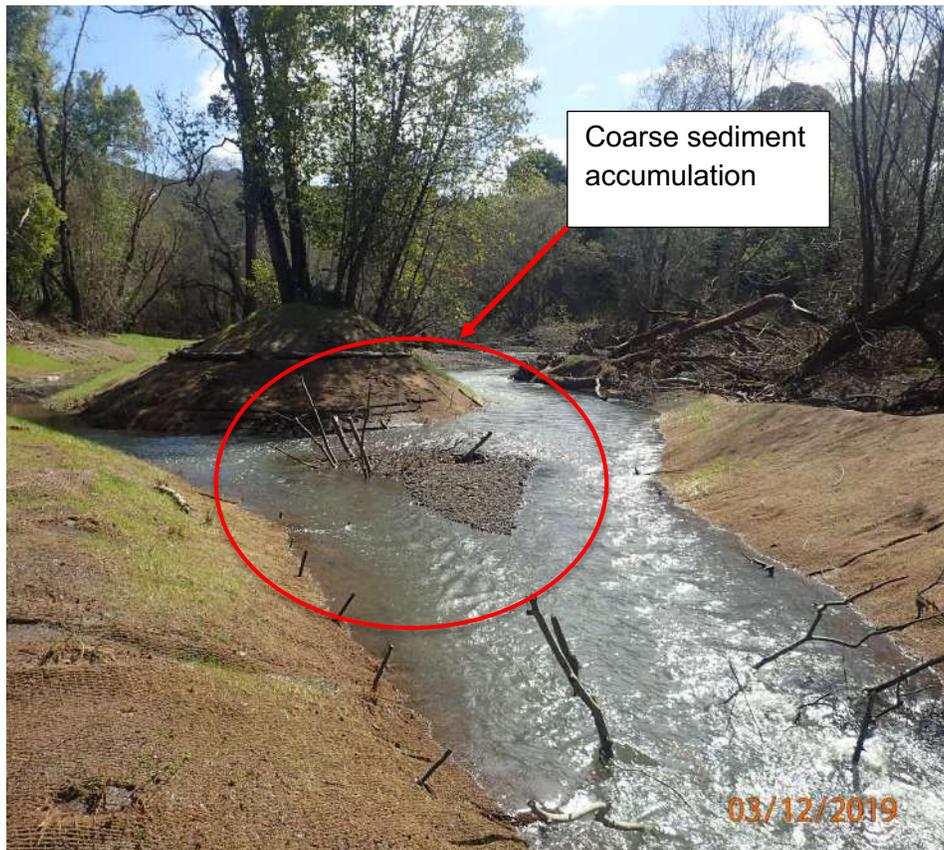
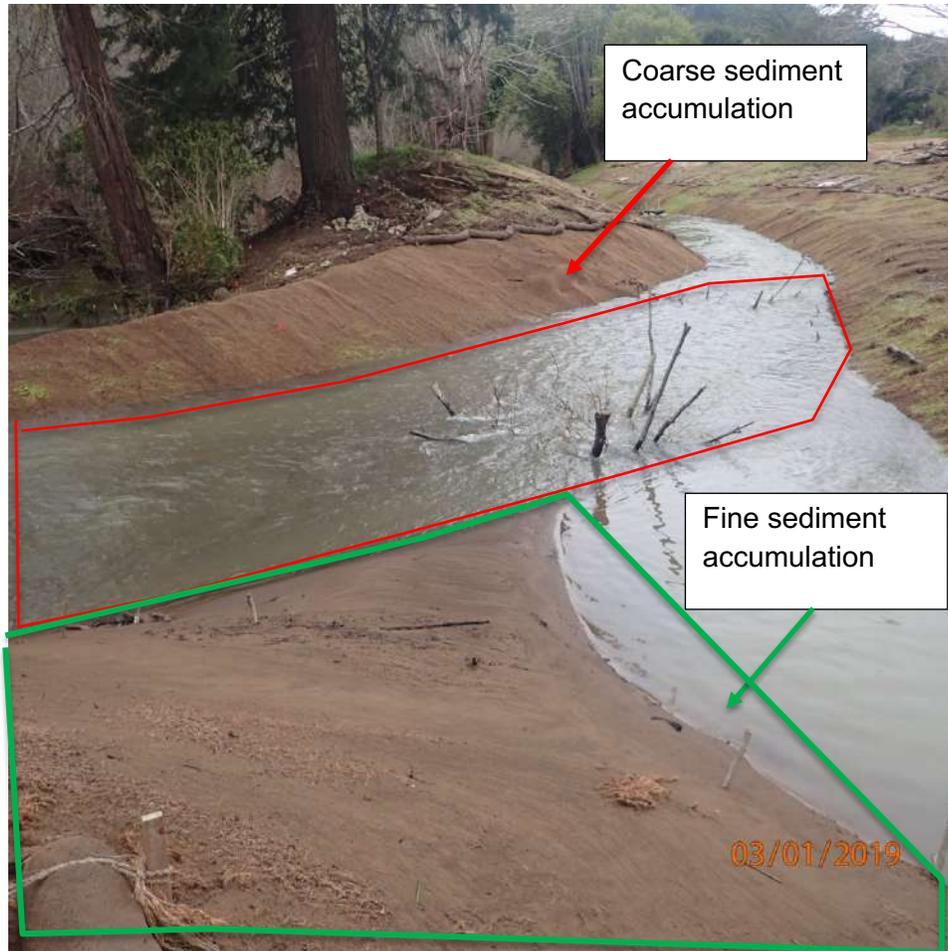
This photo demonstrates the self-sorting capacities of the channel networks. From the left of the photo is the seasonal channel inlet where coarse material has been deposited and transported downstream through the channel. On the right of the photo is a high flow channel that acts primarily as a backwater during flows below bankful (~350 cfs). The accumulation of fine sediment here in this photo is a result of a tree island creating a velocity shadow where slow water and fine sediment accumulate.

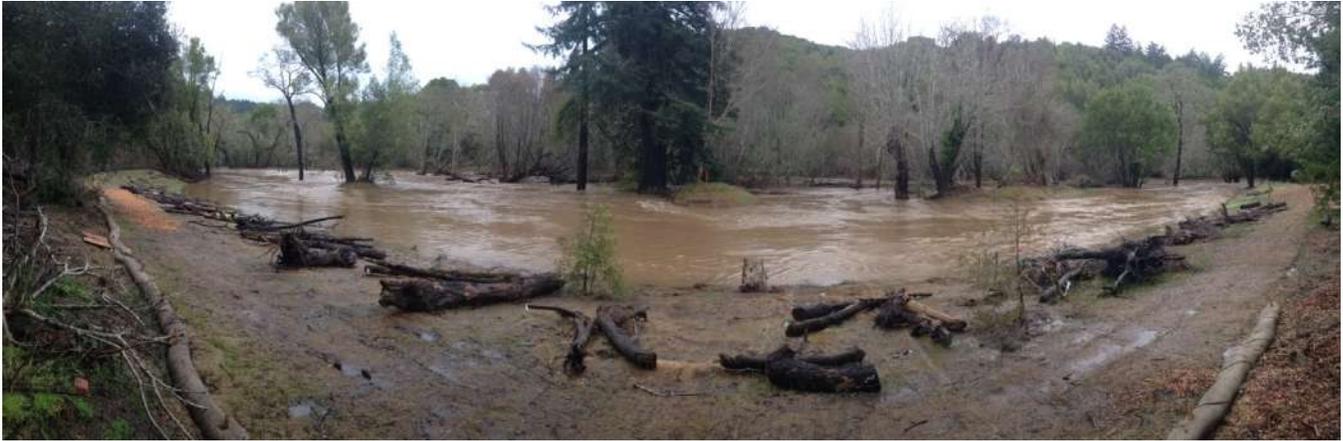
The above picture is of the floodplain after the February 27, 2019 storm where the discharge at the Devils Gulch stream gauge 2 miles upstream read approximately 2,030 cfs. Wood that was passively left on the banks were pulled into the creek and racked up further downstream.

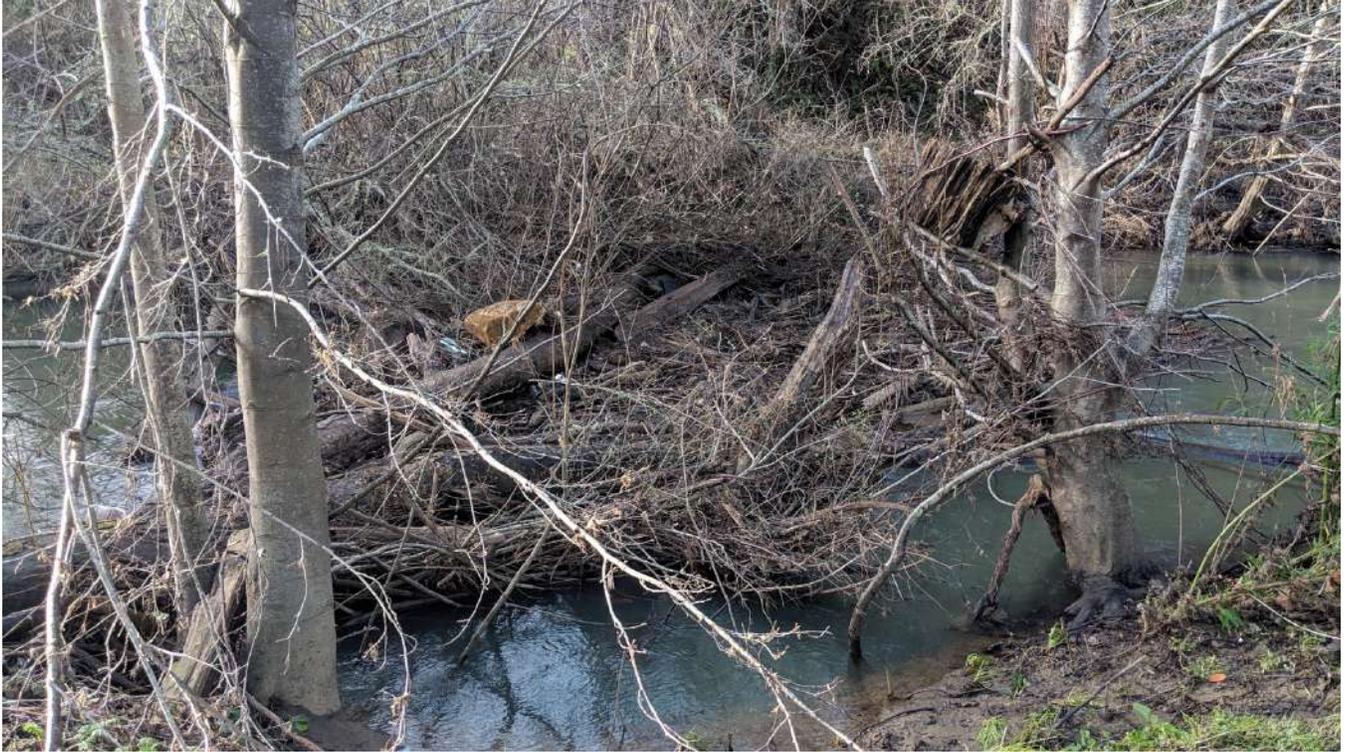
Located in the mainstem of Lagunitas Creek within the project area, this large woody debris jam consisted of 4 key members (>9in diameter), but contained a significant amount of smaller debris that racked up as a result.

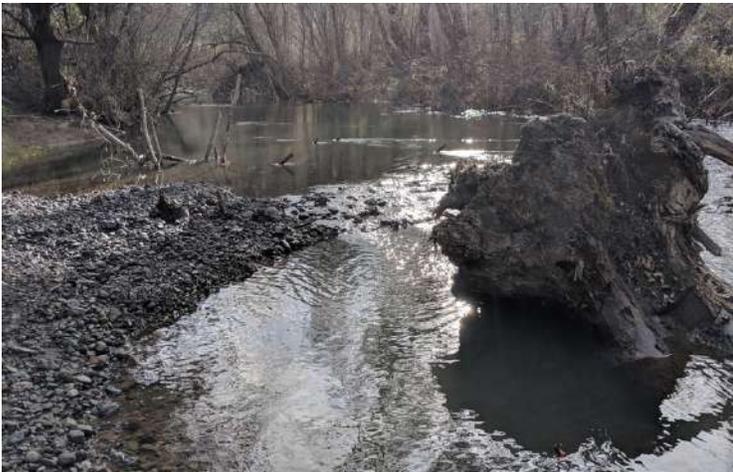
Anchored rootwad, and additional rootwad to left of this one shown was covered in coarse bedload

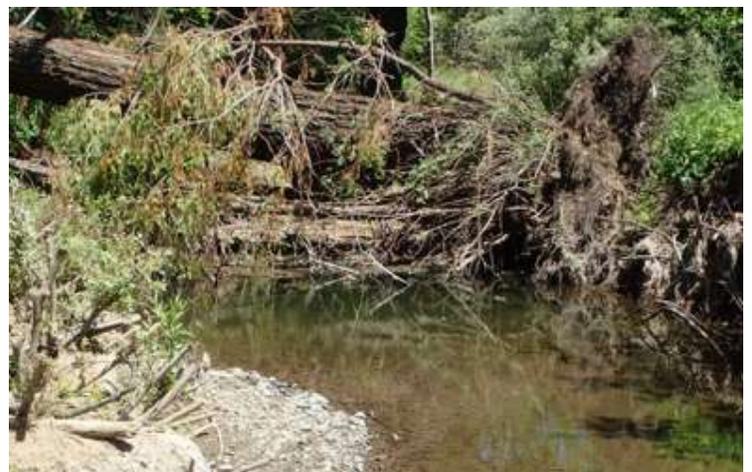
Fallen 4ft diameter redwood into perennial channel

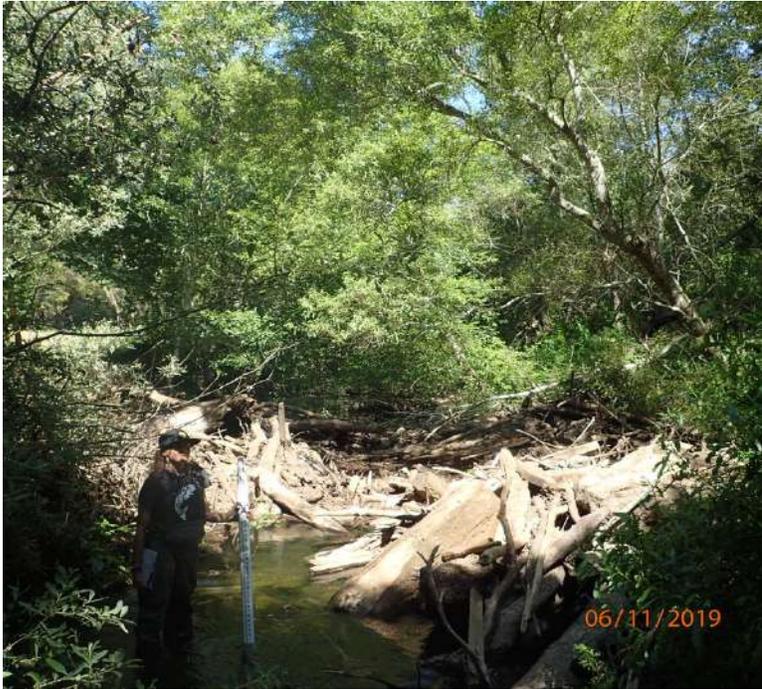
Large woody debris jam formed in mainstem channel.

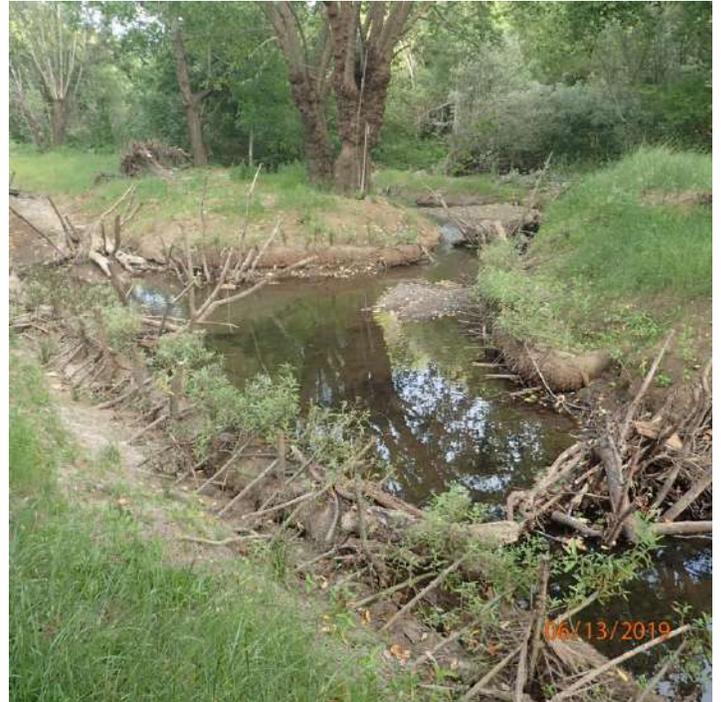
Example of willow pole structure racking small debris

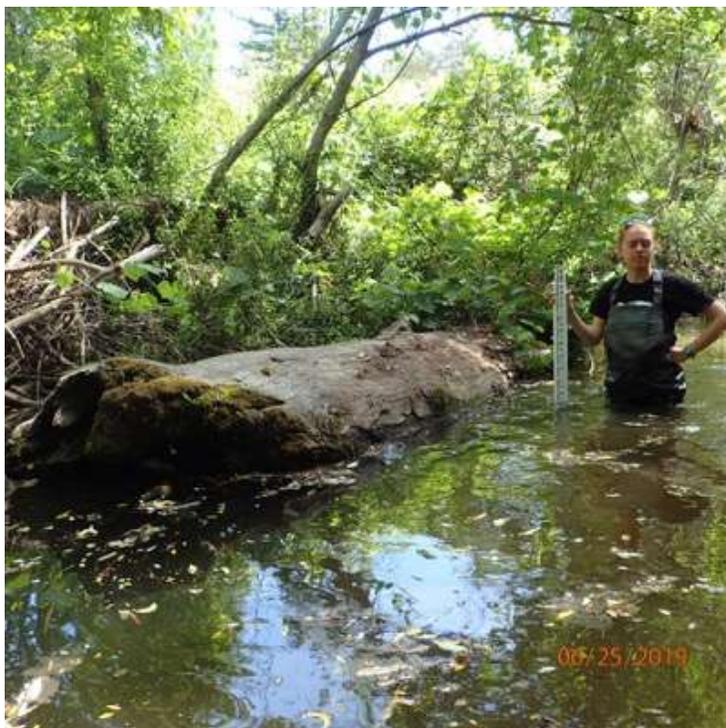
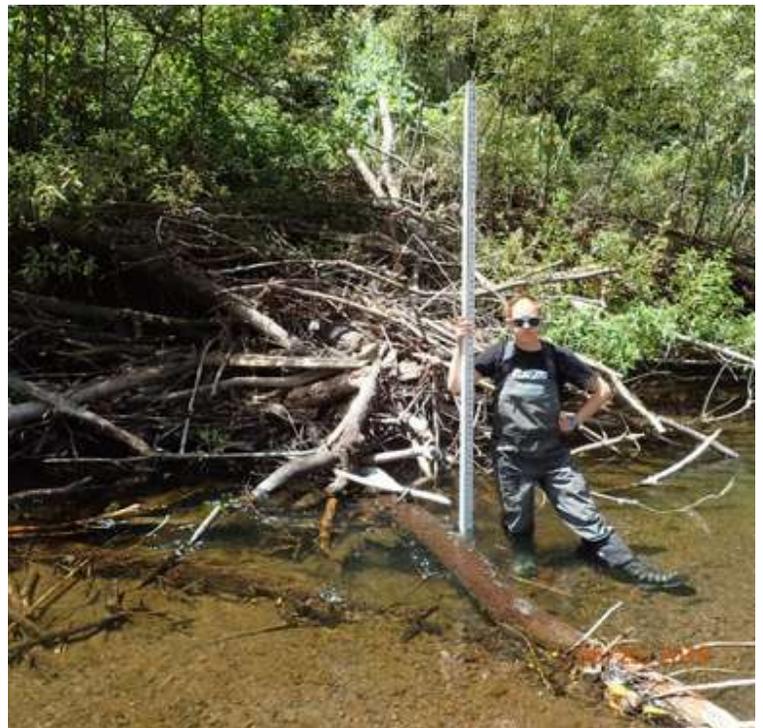
Large log racked up along channel margin Wood rack in mainstem at side channel inlet

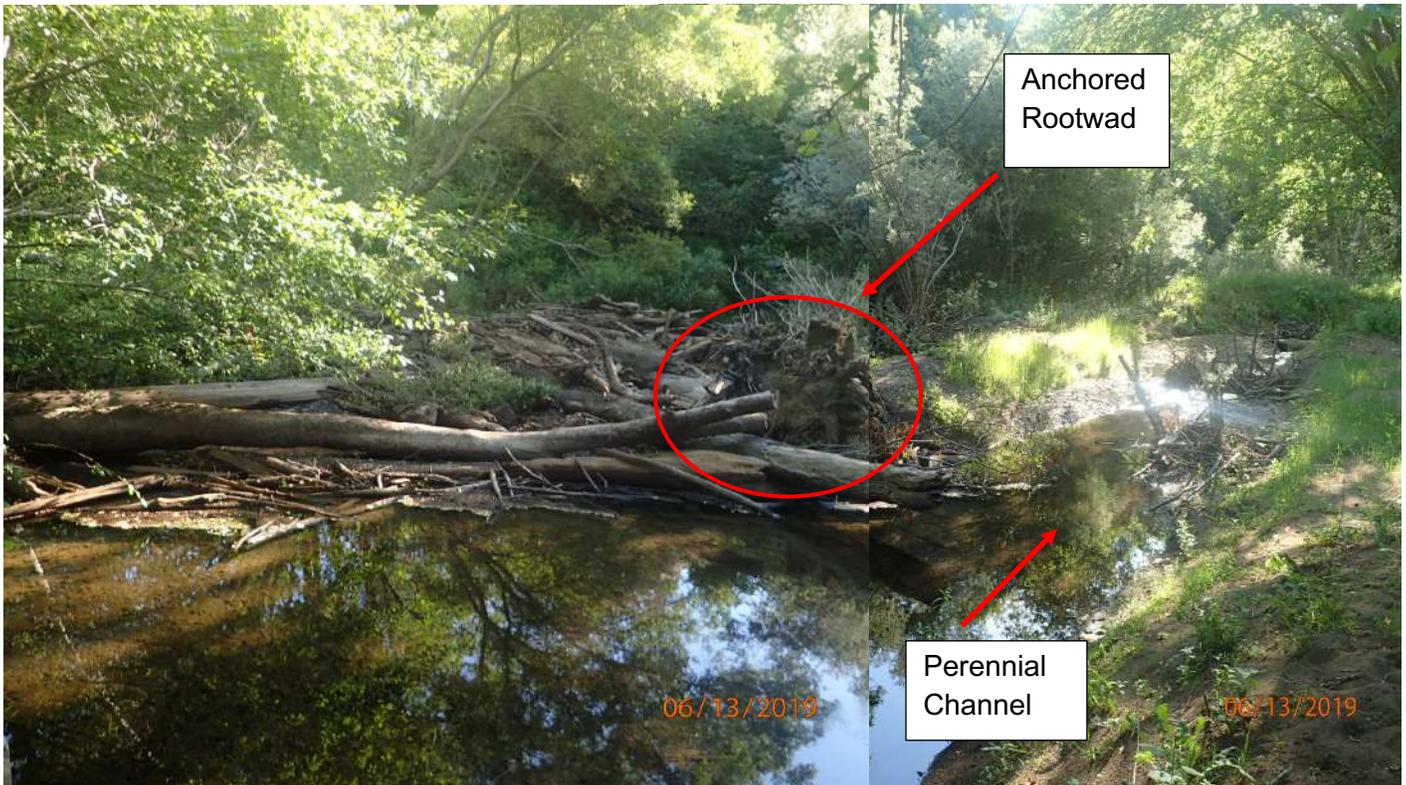
Large woody debris jam located at the connection of the perennial channel with the main stem. Two large anchored logs and rootwads caught large key members and racked the rest of the material.

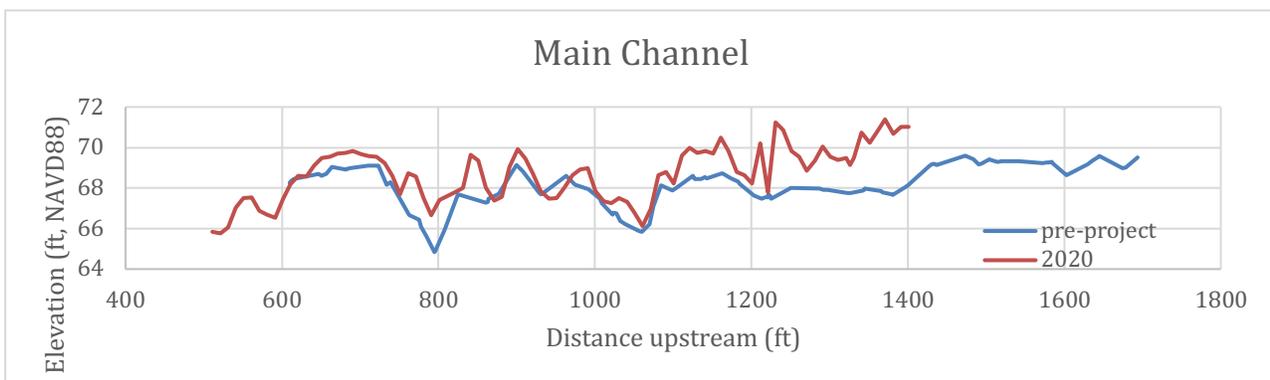
Note the change in channel elevation between stations 1200 and 1400 within the main stem . The resulting difference in channel elevation created a large riffle/pool complex where a placid plane-bed glide existed before. The result also reduced channel incision by three feet.

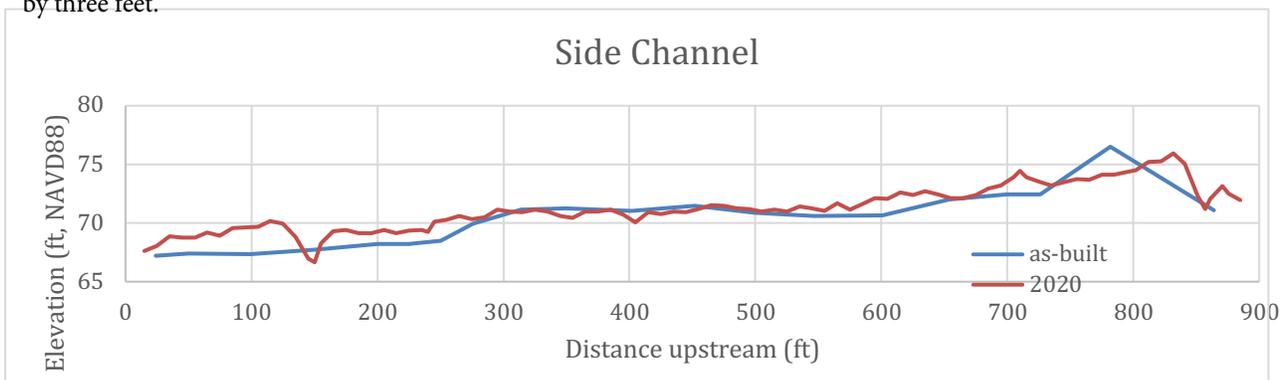
The side channel that was created saw patterns of coarse sediment deposition and erosion, punctuated by large accumulations of sediment and areas of pool scour and erosion. The location between stations 300 and 500 where the featureless channel exists is a result of a slightly steeper section of the channel where transport energy was too high to allow coarse bedload to deposit. Note the large pool at station 150, was created by the scour from a large fallen redwood tree.

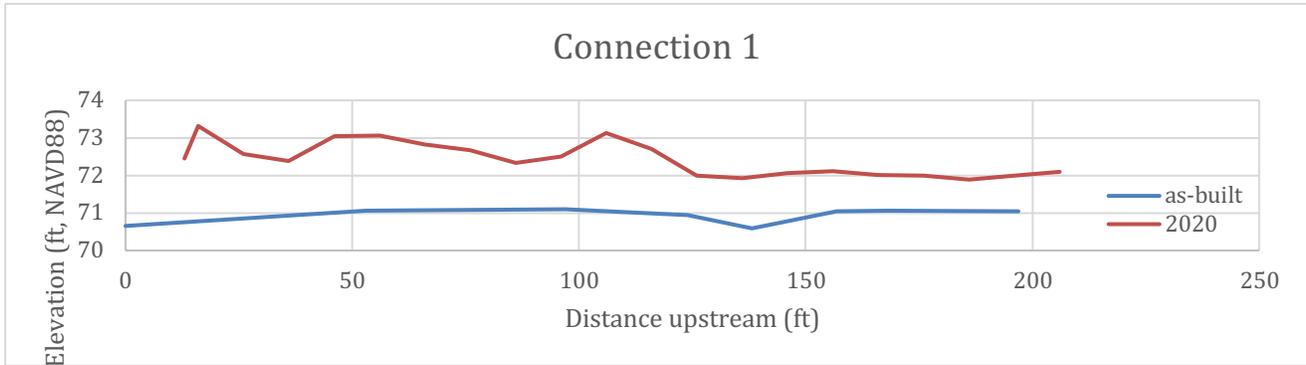
The results indicate that roughly 3 feet of coarse bedload has deposited within the side channel connection. This has resulted in an increase in water surface elevation at the site.

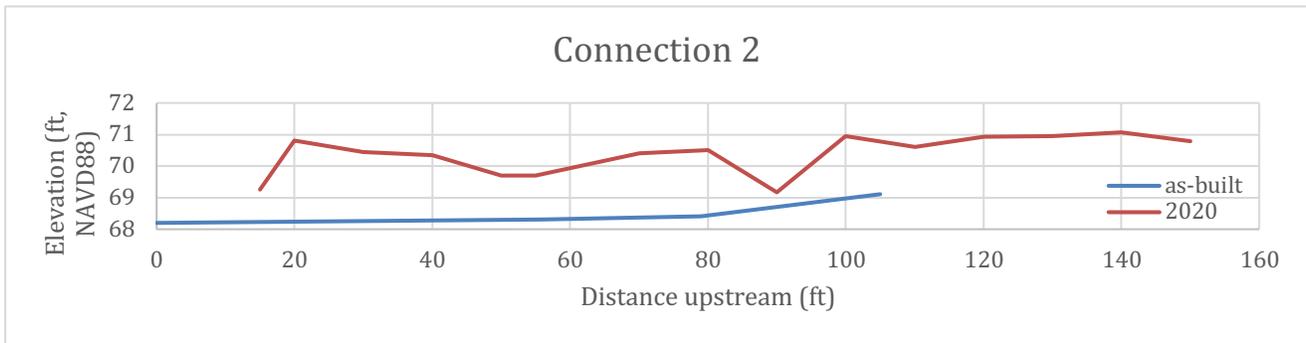
The rise in channel profile and water surface at Connection 2 resulted from a large wood jam that piled up in the mainstem and backed up sediment and water to force flow into the perennial channel (refer to photo on page 17 of large wood jam). This large wood jam accumulated sediment and has led to an increase in water surface elevation, helping force flow into the adjacent side channel.

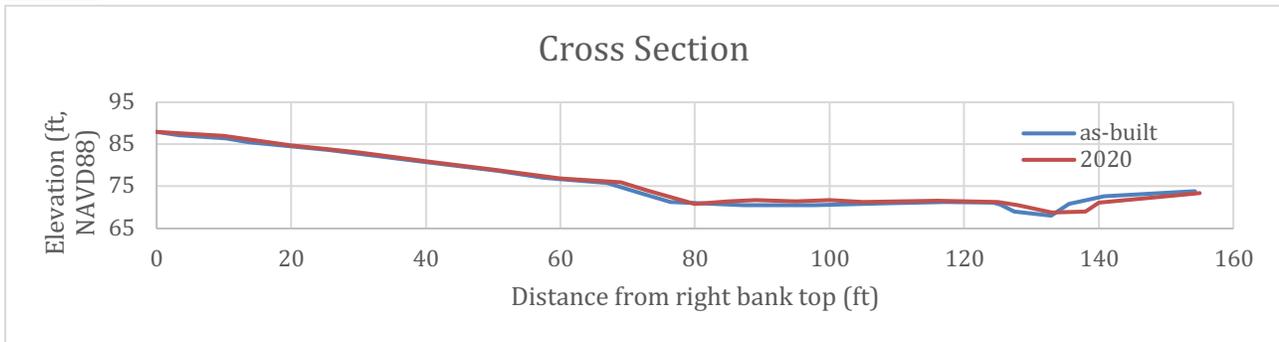
This section shows the difference in elevation along a floodplain cross-section. Although it seems the pool (the dip ~130 ft), has shifted slightly, there has been little change in the channel elevation as a result of the winter flows.
